Cycle Smart Brum Project Summary Report

To gain a better understanding of reported and unreported cycling collisions, near misses and the conditions under which they occur, The Royal Society for the Prevention of Accidents (RoSPA), a leading accident prevention charity, and See.Sense, a cycling tech and data startup, have undertaken Cycle Smart Brum, an innovative, data-driven project.

The project examined reported road casualty data on pedal cycles, published each year by the Department for Transport, and compared this with the measurements collected by the See.Sense light to establish the relationship between reported and unreported incidents with a view to developing a predictive model.

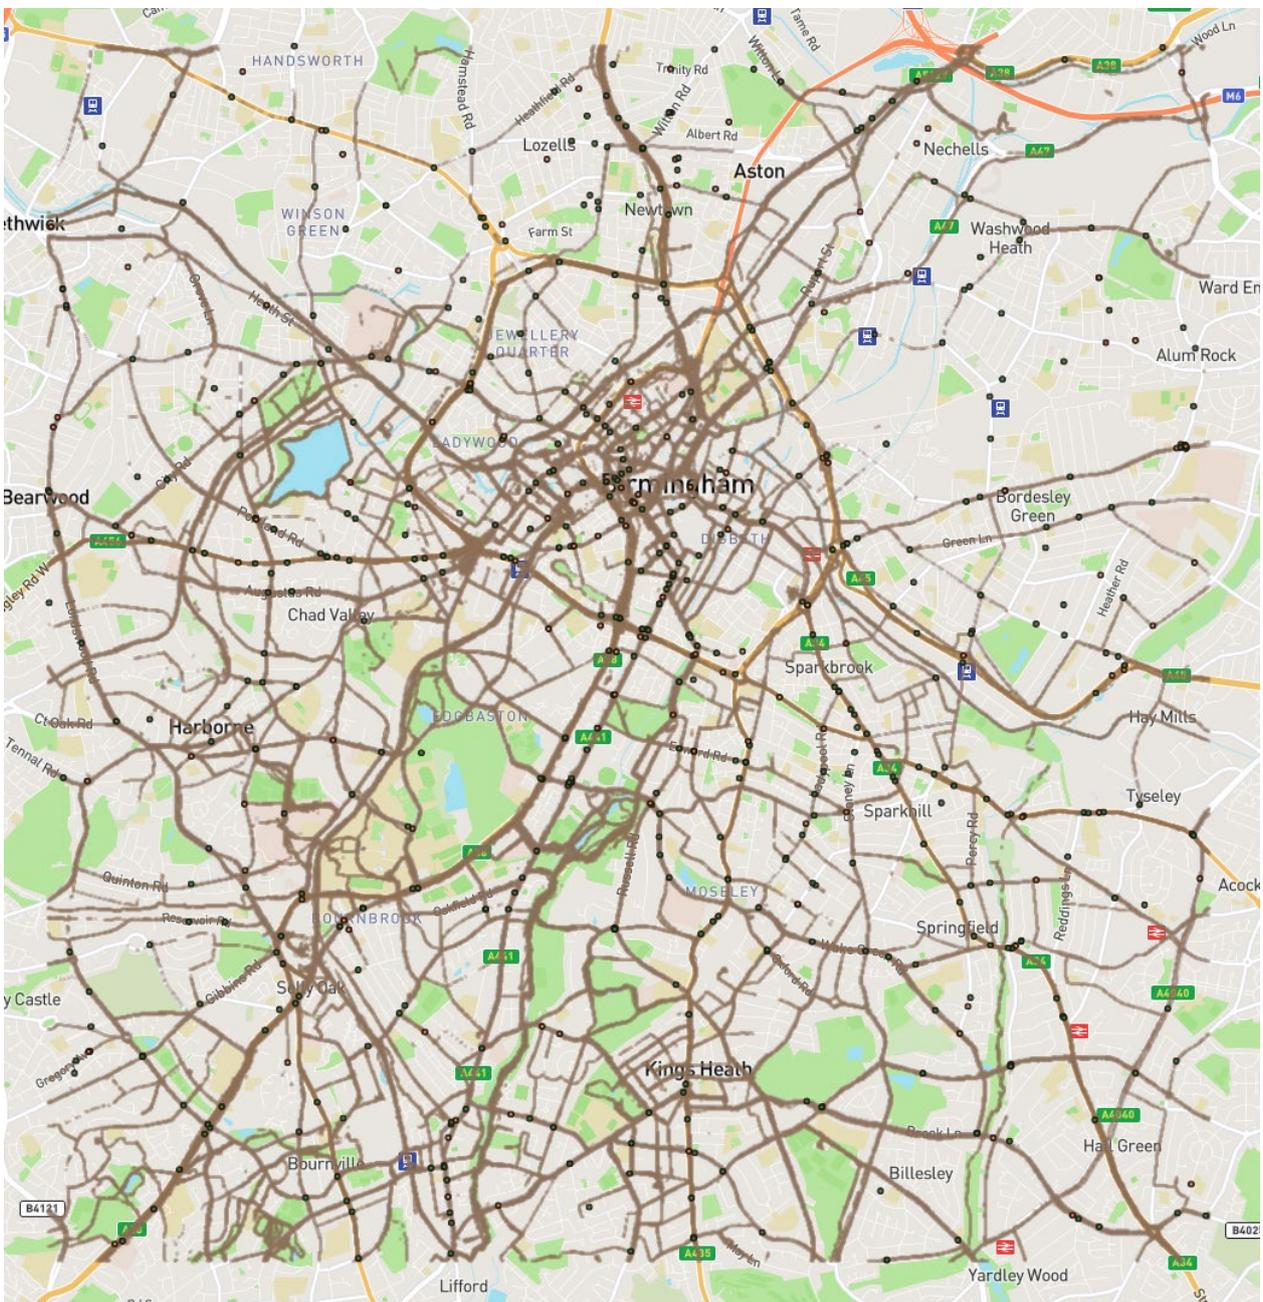
In order to ensure a sufficient data density, we only included tiles with 3 or more cyclists and 15 or more journeys. At this level of coverage, we were able to study 453 (81%) out of 559 STATS19 events. The image below shows the total coverage area and STATS19 locations.

Due to the initial selection criteria targeting city centre cyclists, we had less cycling coverage in the North and East of the study area.

Figure 1: The coverage (brown) and STATS19 locations (dots).
