Occupational Safety of Road Users – Re-establishing the Cost-Effectiveness of High Friction Surfacing Systems

**RoSPA NOSH Committee**

### High Friction Surfacing or Antiskid

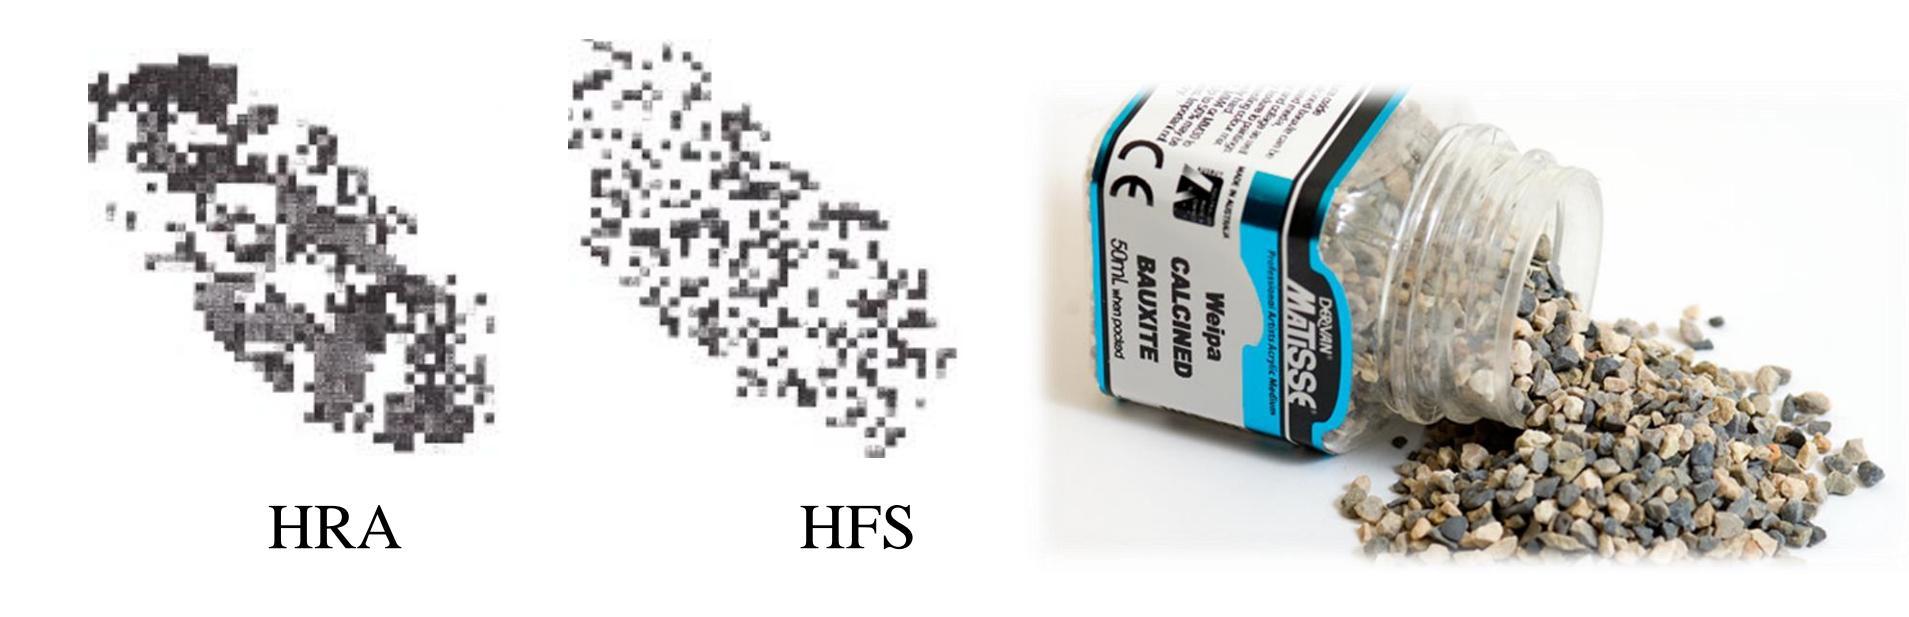
Durable Micro-texture (**Calcined Bauxite aggregate**), reduced contact points, high contact pressure points and improved hydraulic conductivity are critical for high skid resistance and reduced braking distances (Parry, TRL 1996)

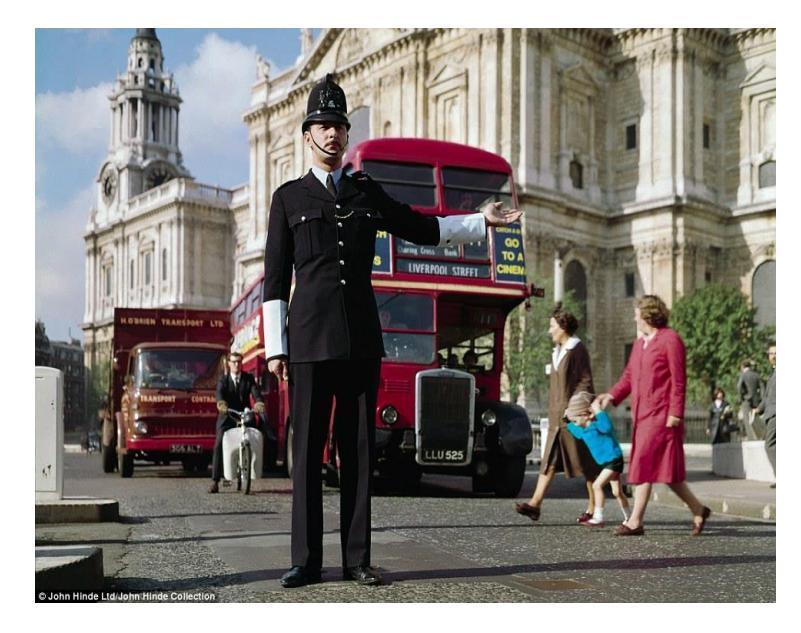
Trials of high friction surfacing started in 1968 – cold applied bitumen extended epoxy resin + calcined bauxite

- Accidents and casualties reduced by 50% in year 1
- Cost of treatment recovered within 1 year
- 10 year programme was instigated
- Programme cost to be covered 8 fold in reduced accident costs
- Effective life of HFS found to exceed **<u>10 years</u>**

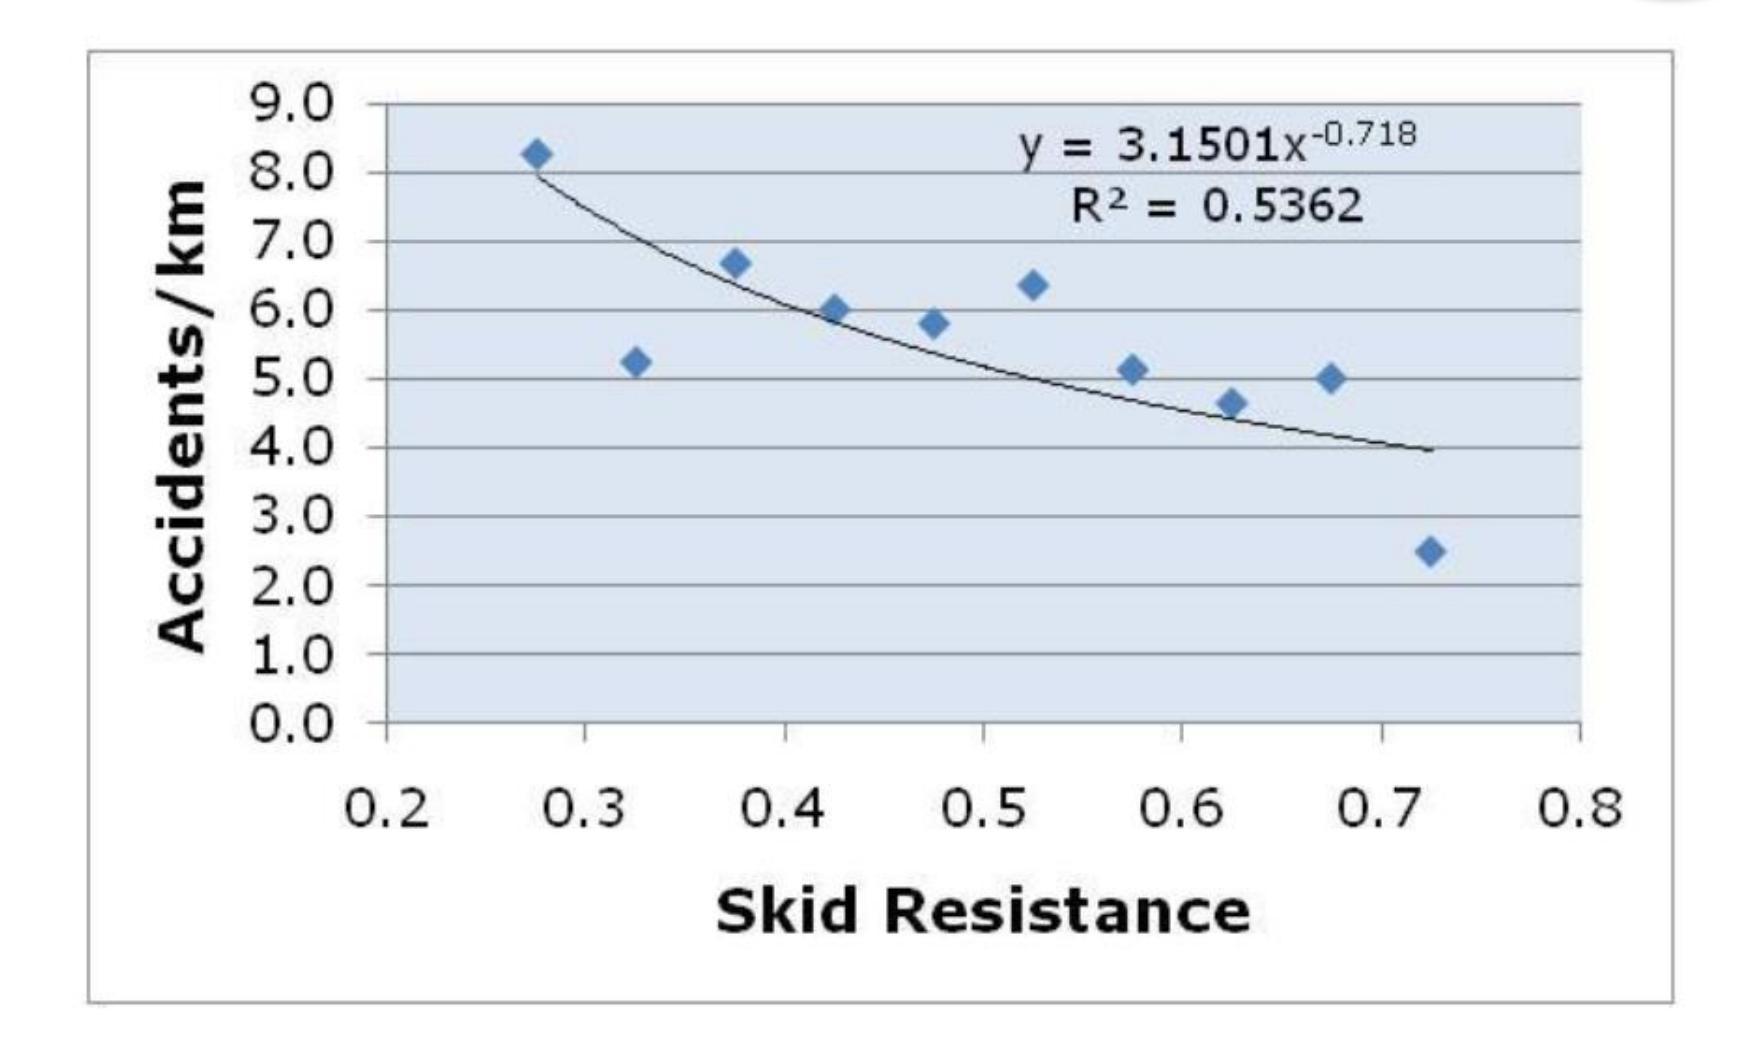
### Approaches to pelican crossings (LotAG 2009)

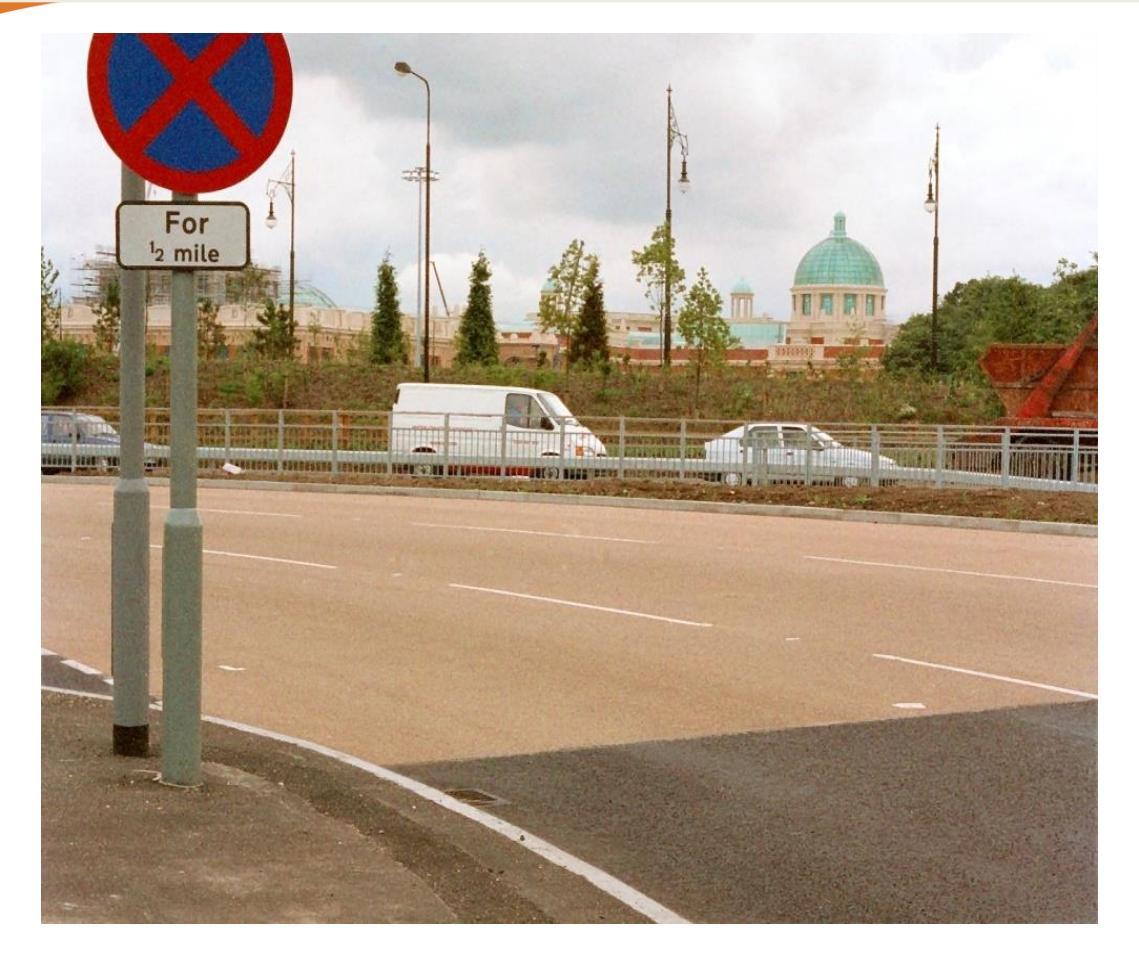
### Cold applied more than 10 years old

### (Trafford Centre M60 off slips & junction installed 1999) Cold applied MMA system

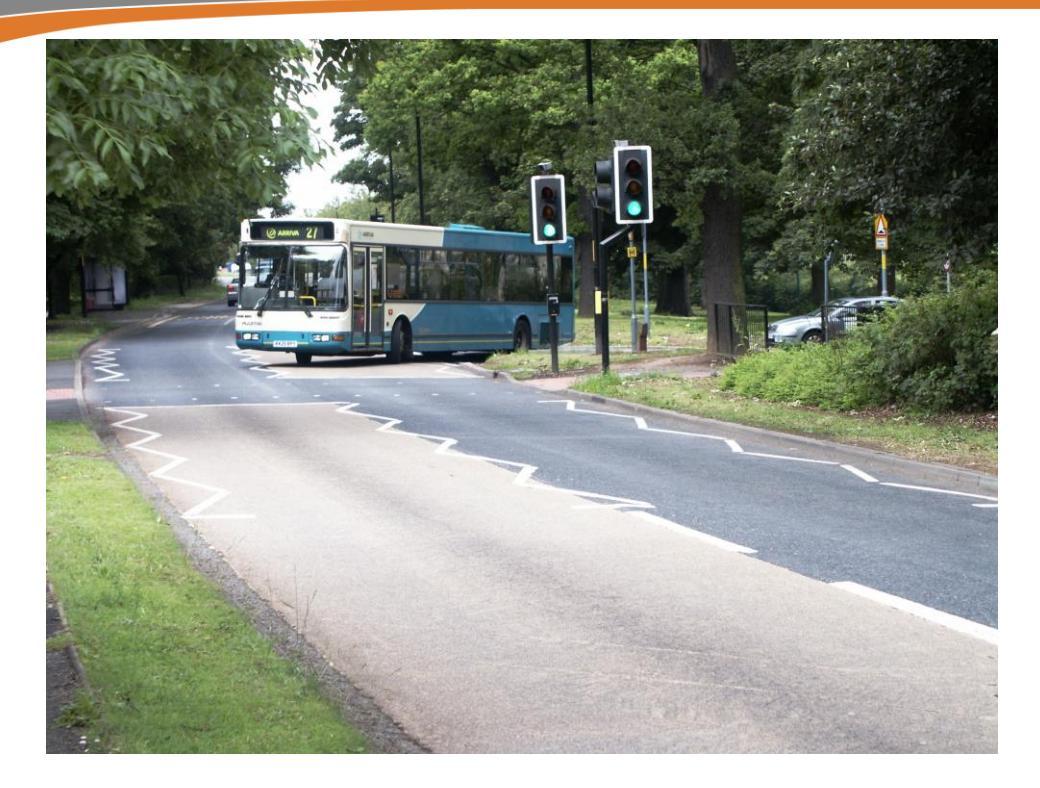
Leading edge after 7 years

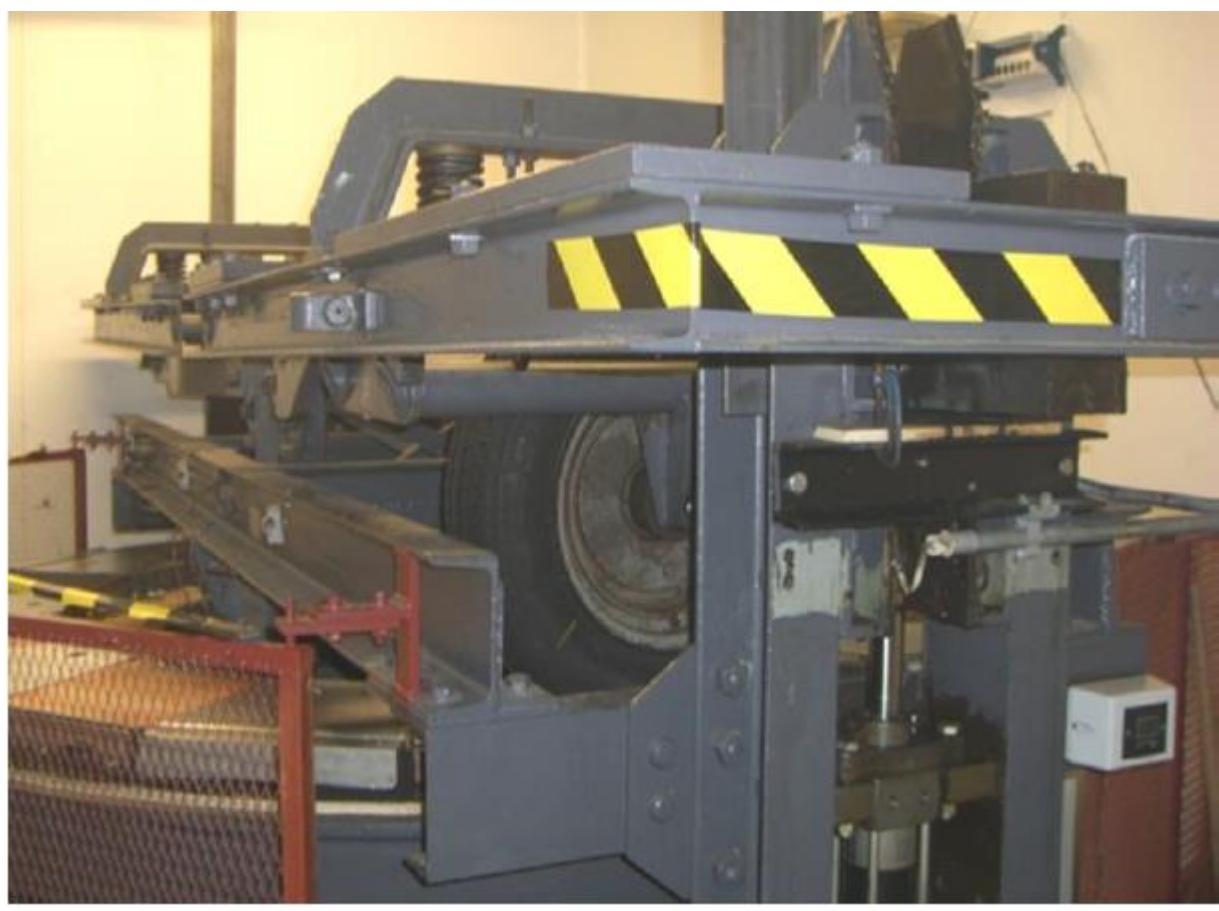
#### Road Test Machine – Ulster University

Testing was carried out using the Road Test Machine (RTM) for a total of 100,000 wheel passes. The RTM is used to simulate slow speed / high stress trafficking in laboratory controlled conditions.

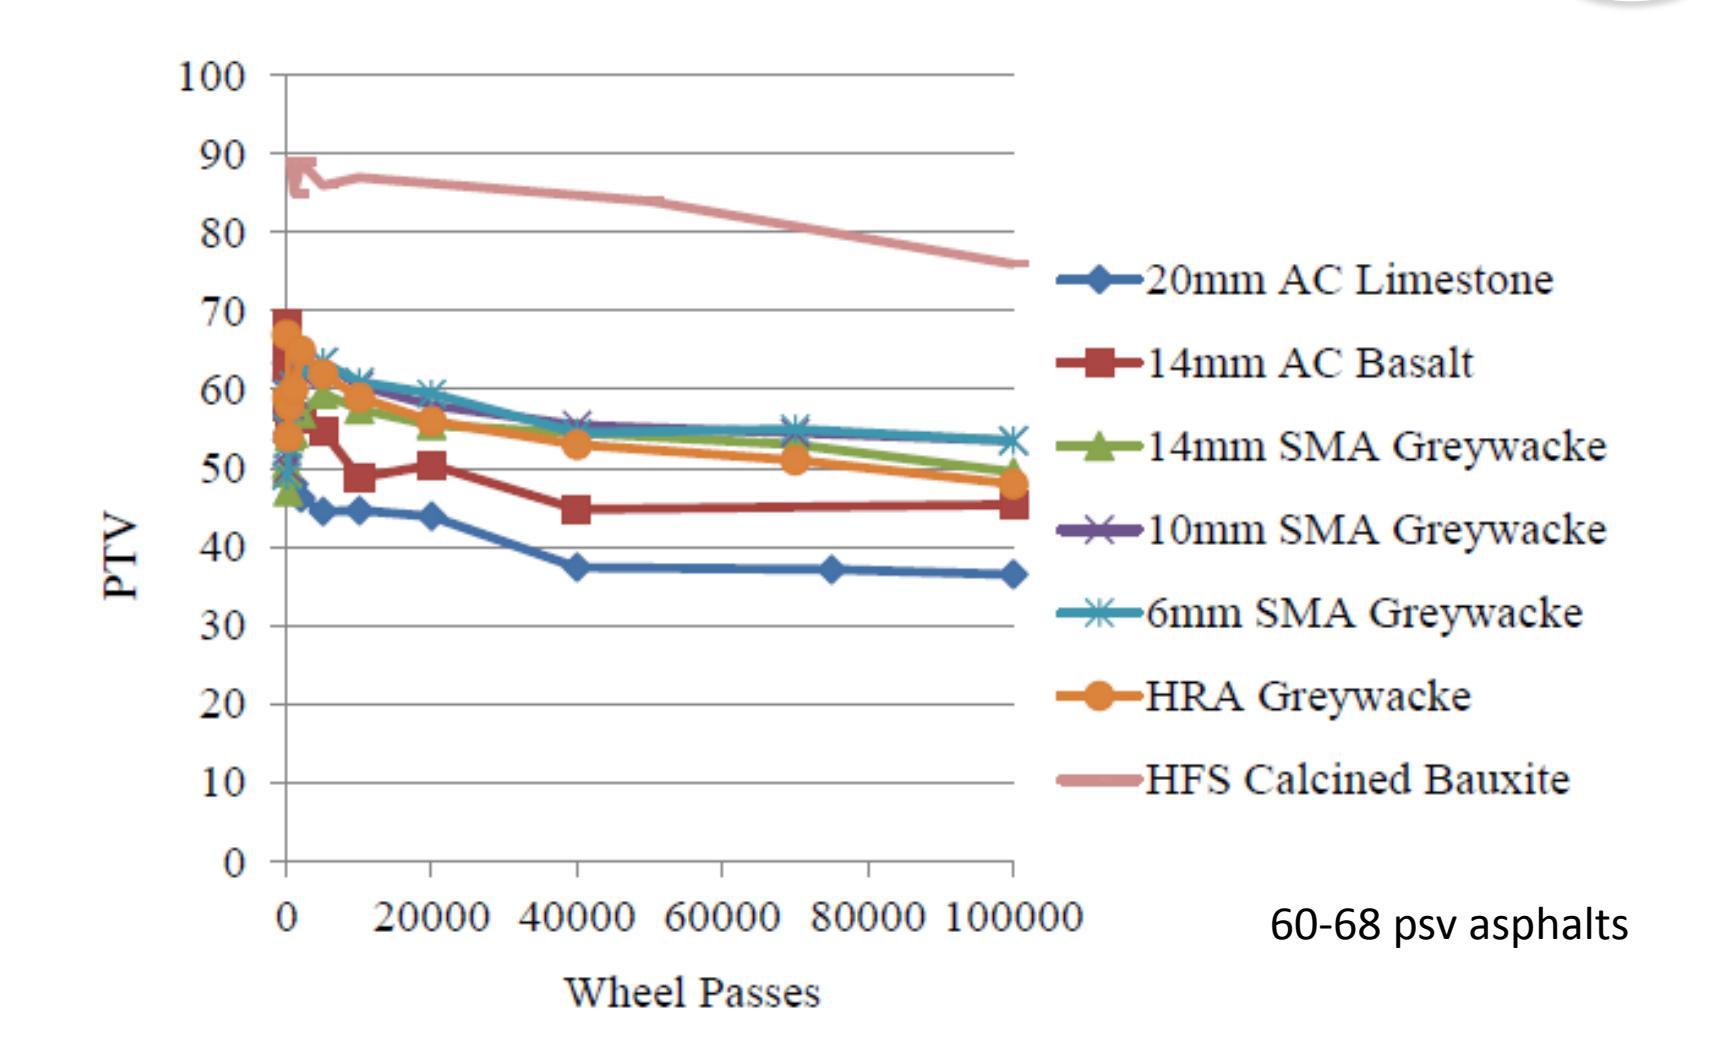
# Average skid resistance after simulated trafficking
